BSA Completed Site Report

| ADDRESS | ZIP CODE | FRONTAGE x DEPTH (ft) | DATE COMPLETED |
|---|---|---|---|
| 34 Lathrop | 14212 | 30x94 | 8/6/2015 |

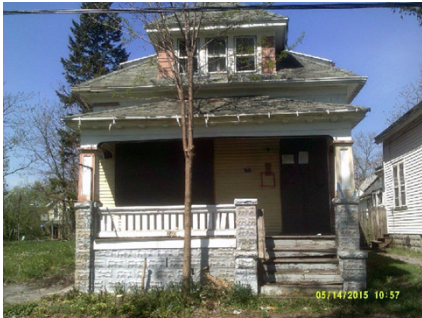
1.

| RUBBLE/DEBRIS, TYPE: | Rubble from in-fill. |

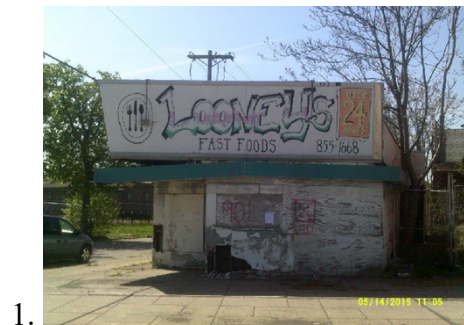
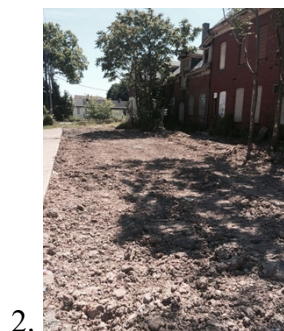
Before:

| RUBBLE/DEBRIS, TYPE: | Rubble from in-fill. |

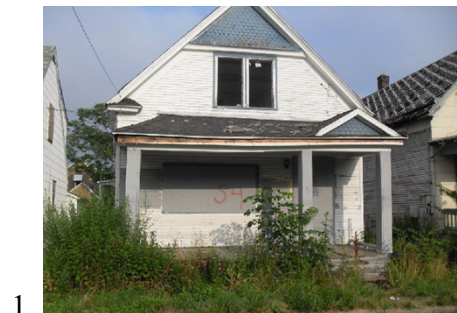
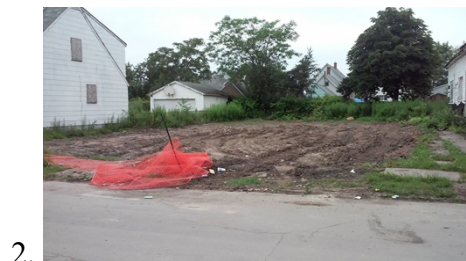
Before:

| RUBBLE/DEBRIS, TYPE: | Excessive rubble turned up during scarification from in-fill following demolition. |
| FURTHER NOTES: | Uneven grade, non-woody vegetation along side and rear of lot, 1 large rock was uncovered, torn fence left in back of lot, and fallen but still rooted evergreen tree from neighboring lot. |

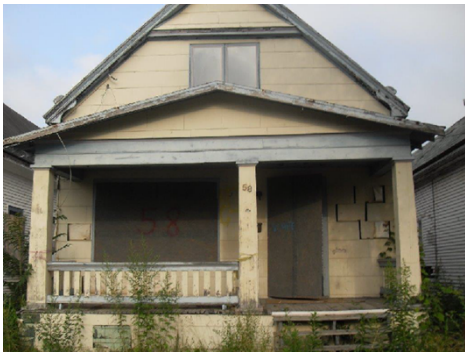
Before:

| RUBBLE/DEBRIS, TYPE: | Excessive rubble left from demolition in-fill soil. |
| FURTHER NOTES: | Uneven grade, non-woody vegetation along side and rear of lot. |

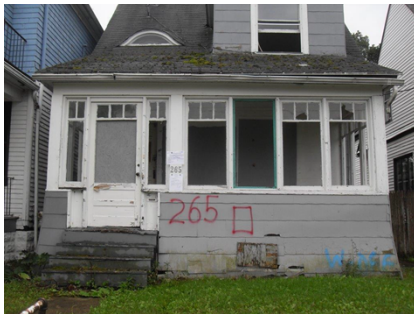
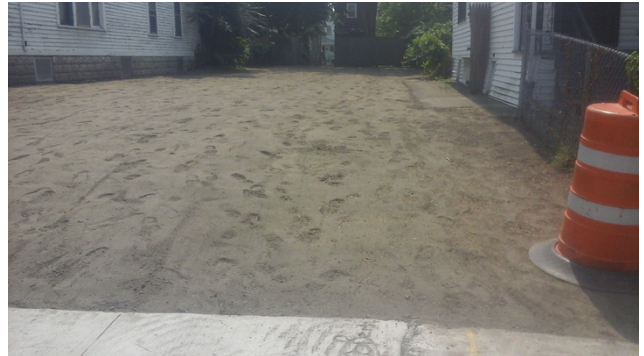
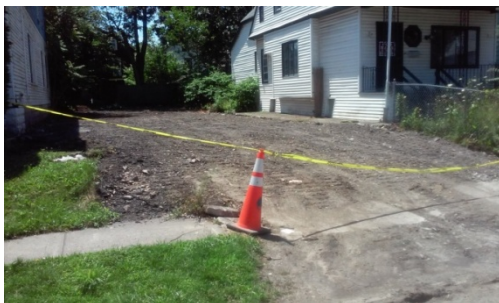
Before:

| FURTHER NOTES: | The lot had a lot of weeds, Japanese knotweed and branches that had to be removed along the fence line. |

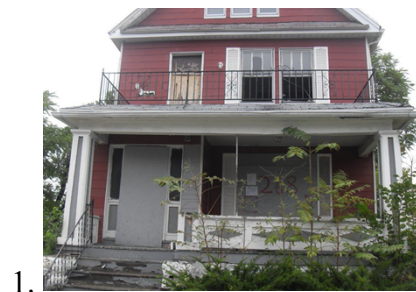
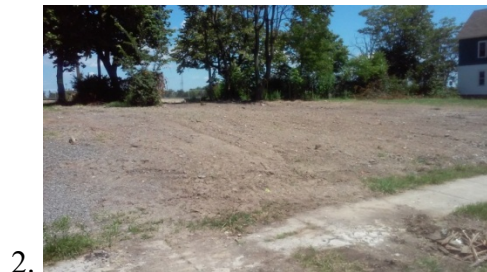
Before:

| RUBBLE/DEBRIS, TYPE: | Cylinder blocks, bricks, stones (see below) |
| FURTHER NOTES: | Uneven grade, weeds, old broken gas lines, and boulders. 4x4 piece of concrete found in lot, huge stones, branches, bricks, and cylinder blocks found when lot was scarified. |
