BSA Completed Site Report

ADDRESS	ZIP CODE	FRONTAGE x DEPTH (ft)	DATE COMPLETED
69 May	14211	30x123	7/24/2015

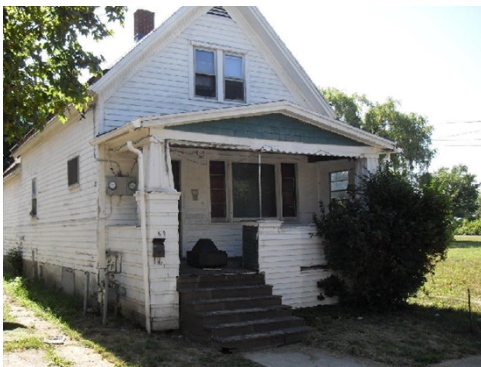
1.

SITE CONDITIONS:	Dry, sunny.
AMOUNT OF TOPSOIL USED ON SITE:	40 yards
HYDRO SEED/HAND SEED:	Hand seed
AMOUNT OF SEED USED ON SITE:	18.45 pounds
MACHINERY USED:	Skidsteer with scarifier and bucket, rakes, seed spreader, roller.
RUBBLE/DEBRIS, TYPE:	Rubble upturned during scarification from demolition in-fill.
RAINCHECK SIGN:	
FURTHER NOTES:	Tires dumped in lot had to be removed.
PHOTOGRAPHS OF SITE:	Before (1,2) and After, attached below.

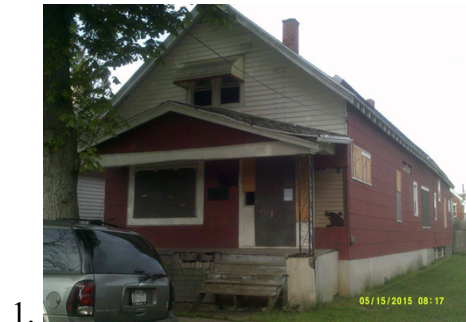
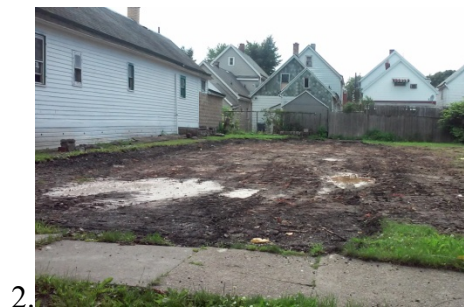
Before:

SITE CONDITIONS:	Sunny, dry.
AMOUNT OF TOPSOIL USED ON SITE:	40 yards
HYDRO SEED/HAND SEED:	Hand seed
AMOUNT OF SEED USED ON SITE:	17.5 pounds
MACHINERY USED:	Skidsteer with scarifier and bucket, rakes, seed spreader, roller.
RUBBLE/DEBRIS, TYPE:	In-fill rocky
RAINCHECK SIGN:	
PHOTOGRAPHS OF SITE:	Before (1,2) and After, attached below.

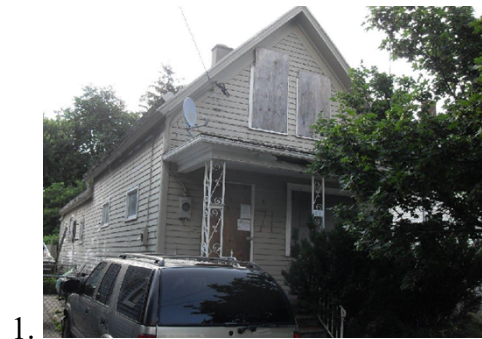
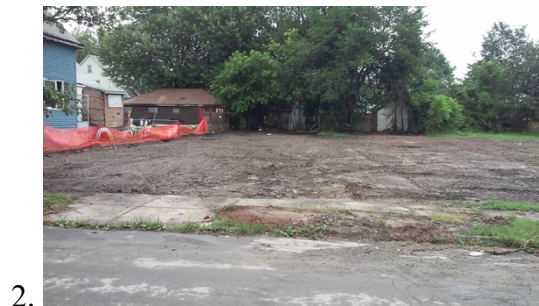
Before:

SITE CONDITIONS:	Dry, sunny
AMOUNT OF TOPSOIL USED ON SITE:	40 yards
HYDRO SEED/HAND SEED:	Hand seed
AMOUNT OF SEED USED ON SITE:	18.45 pounds
MACHINERY USED:	Skidsteer with scarifier and bucket, rakes, seed spreader, roller.
RUBBLE/DEBRIS, TYPE:	Small rubble from demolition
RAINCHECK SIGN:	
FURTHER NOTES:	Tires that had been dumped had to be removed from the site prior to installation.
PHOTOGRAPHS OF SITE:	Before and After, attached below.

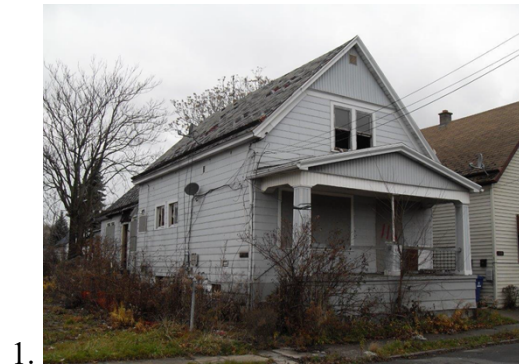
Before:

SITE CONDITIONS:	Dry, sunny, hot
AMOUNT OF TOPSOIL USED ON SITE:	40 yards
HYDRO SEED/HAND SEED:	Hand seed
AMOUNT OF SEED USED ON SITE:	14 pounds
MACHINERY USED:	Skidsteer with scarifier and bucket, rakes, seed spreader, roller.
RUBBLE/DEBRIS, TYPE:	Rocks and roots.
RAINCHECK SIGN:	
PHOTOGRAPHS OF SITE:	Before (1, 2) and After, attached below.

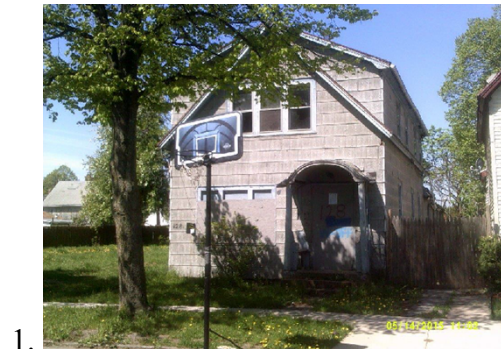
Before:

SITE CONDITIONS:	Dry and cloudy
AMOUNT OF TOPSOIL USED ON SITE:	50 yards
HYDRO SEED/HAND SEED:	Hydro seed
AMOUNT OF SEED USED ON SITE:	21 pounds
MACHINERY USED:	Skidsteer with bucket and scarifier, rakes, seed spreader, roller.
RUBBLE/DEBRIS, TYPE:	Very large concrete slabs, large sticks
RAINCHECK SIGN:	
PHOTOGRAPHS OF SITE:	Before (1,2) and After, attached below.

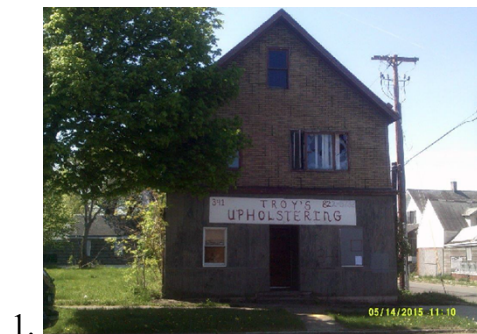
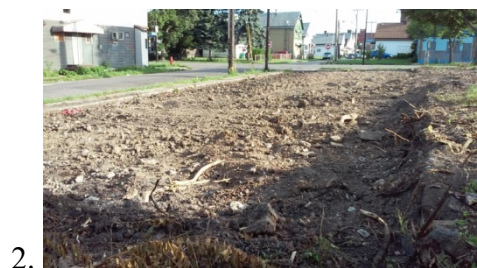
Before:

SITE CONDITIONS:	Dry, very sloped site
AMOUNT OF TOPSOIL USED ON SITE:	50 yards
HYDRO SEED/HAND SEED:	Hand seed
AMOUNT OF SEED USED ON SITE:	15 pounds
MACHINERY USED:	Skidsteer with scarifier and bucket, rakes, seed spreader, roller.
RUBBLE/DEBRIS, TYPE:	Rocky in-fill
RAINCHECK SIGN:	
FURTHER NOTES:	Significant slope and low areas requiring additional soil.
PHOTOGRAPHS OF SITE:	Before (1,2) and After, attached below.

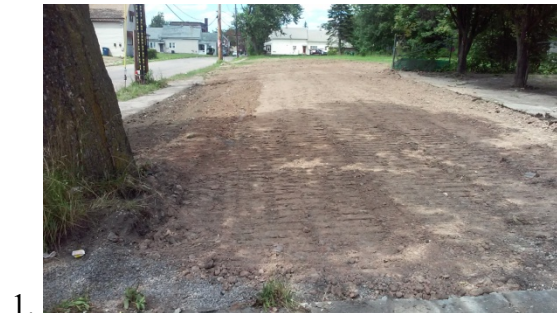
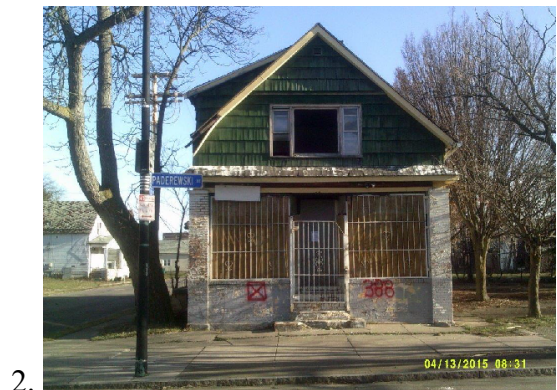
Before:

SITE CONDITIONS:	Sunny, dry
AMOUNT OF TOPSOIL USED ON SITE:	40 yards
HYDRO SEED/HAND SEED:	Hand seed
AMOUNT OF SEED USED ON SITE:	11.5 pounds
MACHINERY USED:	Skidsteer with scarifier and bucket, rakes, seed spreader, roller.
RUBBLE/DEBRIS, TYPE:	In-fill rocky, large stones
RAINCHECK SIGN:	
PHOTOGRAPHS OF SITE:	Before (1, 2) and After, attached below.
