BSA Completed Site Report

| ADDRESS | ZIP CODE | FRONTAGE x DEPTH (ft) | DATE COMPLETED |
|---|---|---|---|
| 34 Lathrop | 14212 | 30x94 | 8/6/2015 |

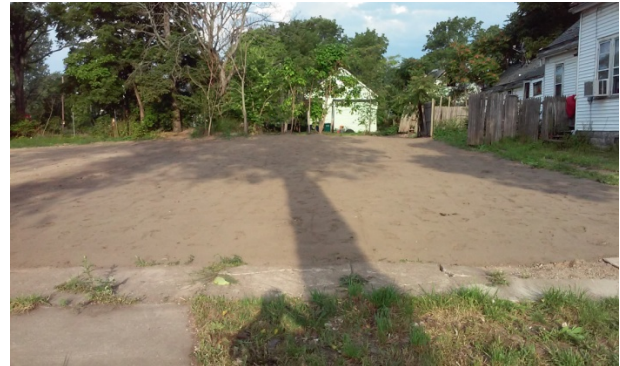
After:

| RUBBLE/DEBRIS, TYPE: | Rubble from in-fill. |

| AMOUNT OF TOPSOIL USED ON SITE: | 40 yards |
| HYDRO SEED/HAND SEED: | Hand seed |
| AMOUNT OF SEED USED ON SITE: | 13.5 pounds |
| MACHINERY USED: | Skidsteer with bucket and scarafier, rakes, seed spreader, roller. |

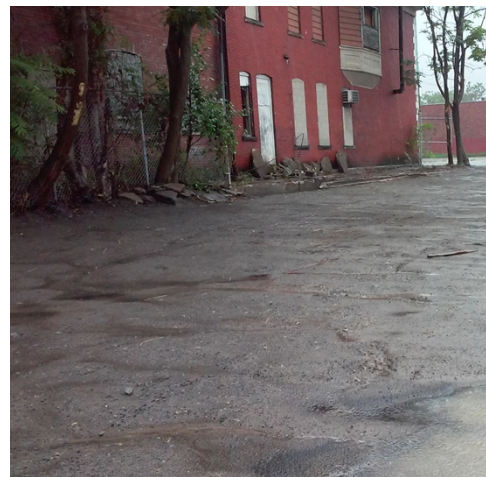
After:

| RUBBLE/DEBRIS, TYPE: | Rubble from in-fill. |

| AMOUNT OF TOPSOIL USED ON SITE: | 40 yards |
| HYDRO SEED/HAND SEED: | Hand seed |
| AMOUNT OF SEED USED ON SITE: | 13.3 lbs |
| MACHINERY USED: | Skidsteer with scarifier and bucket, rakes, seed spreader, roller. |

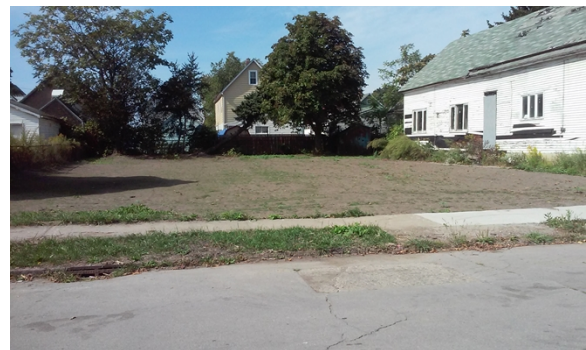
After:

| RUBBLE/DEBRIS, TYPE: | Excessive rubble turned up during scarification from in-fill following demolition. |
| FURTHER NOTES: | Uneven grade, non-woody vegetation along side and rear of lot, 1 large rock was uncovered, torn fence left in back of lot, and fallen but still rooted evergreen tree from neighboring lot. |

| AMOUNT OF TOPSOIL USED ON SITE: | 40 yards |
| HYDRO SEED/HAND SEED: | Hand seed |
| AMOUNT OF SEED USED ON SITE: | 17.25 lbs |
| MACHINERY USED: | Skidsteer with scarifier and bucket, rakes, seed spreader, roller. |

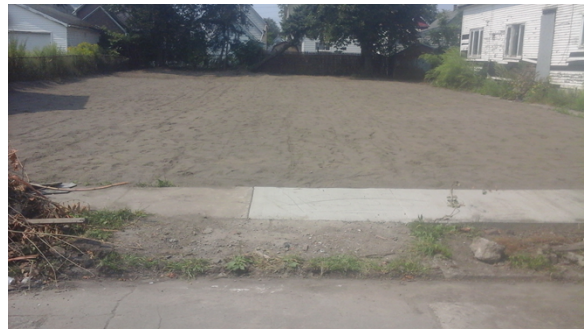
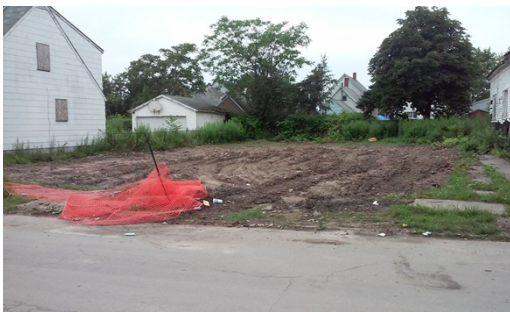
After:

| RUBBLE/DEBRIS, TYPE: | Excessive rubble left from demolition in-fill soil. |
| FURTHER NOTES: | Uneven grade, non-woody vegetation along side and rear of lot. |

| AMOUNT OF TOPSOIL USED ON SITE: | 35 yards |
| HYDRO SEED/HAND SEED: | Hand seed |
| AMOUNT OF SEED USED ON SITE: | 17.25 pounds |
| MACHINERY USED: | Skidsteer with scarifier and bucket, rakes, seed spreader, roller. |

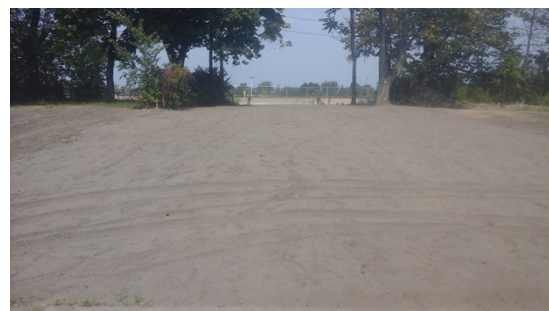
After:

| FURTHER NOTES: | Uneven grade, weeds, old broken gas lines, and boulders. 4x4 piece of concrete found in lot, huge stones, branches, bricks, and cylinder blocks found when lot was scarified. |

| AMOUNT OF TOPSOIL USED ON SITE: | 40 yards |
| HYDRO SEED/HAND SEED: | Hand seed |
| AMOUNT OF SEED USED ON SITE: | 17 yards |
