BSA Completed Site Report

ADDRESS	ZIP CODE	FRONTAGE x DEPTH (ft)	DATE COMPLETED
69 May	14211	30x123	7/24/2015

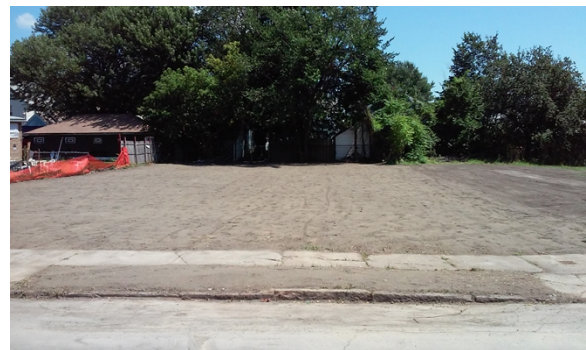
After:

SITE CONDITIONS:	Dry, sunny.
AMOUNT OF TOPSOIL USED ON SITE:	40 yards
HYDRO SEED/HAND SEED:	Hand seed
AMOUNT OF SEED USED ON SITE:	18.45 pounds
MACHINERY USED:	Skidsteer with scarifier and bucket, rakes, seed spreader, roller.
RUBBLE/DEBRIS, TYPE:	Rubble upturned during scarification from demolition in-fill.
RAINCHECK SIGN:	
FURTHER NOTES:	Tires dumped in lot had to be removed.
PHOTOGRAPHS OF SITE:	Before (1,2) and After, attached below.

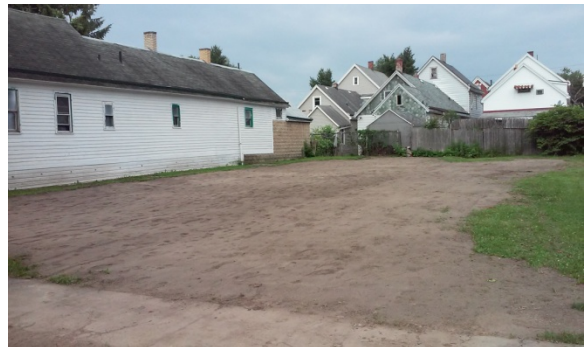
After:

SITE CONDITIONS:	Sunny, dry.
AMOUNT OF TOPSOIL USED ON SITE:	40 yards
HYDRO SEED/HAND SEED:	Hand seed
AMOUNT OF SEED USED ON SITE:	17.5 pounds
MACHINERY USED:	Skidsteer with scarifier and bucket, rakes, seed spreader, roller.
RUBBLE/DEBRIS, TYPE:	In-fill rocky
RAINCHECK SIGN:	
PHOTOGRAPHS OF SITE:	Before (1,2) and After, attached below.

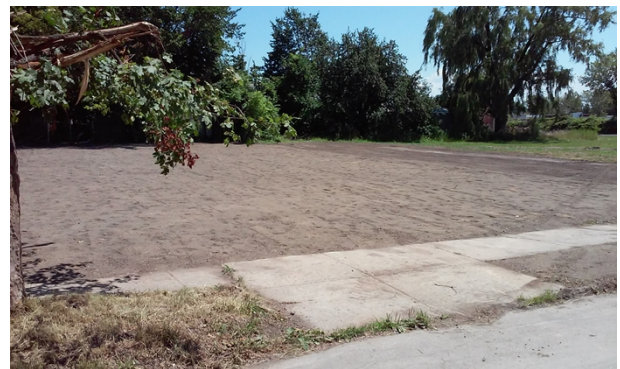
After:

SITE CONDITIONS:	Dry, sunny
AMOUNT OF TOPSOIL USED ON SITE:	40 yards
HYDRO SEED/HAND SEED:	Hand seed
AMOUNT OF SEED USED ON SITE:	18.45 pounds
MACHINERY USED:	Skidsteer with scarifier and bucket, rakes, seed spreader, roller.
RUBBLE/DEBRIS, TYPE:	Small rubble from demolition
RAINCHECK SIGN:	
FURTHER NOTES:	Tires that had been dumped had to be removed from the site prior to installation.
PHOTOGRAPHS OF SITE:	Before and After, attached below.

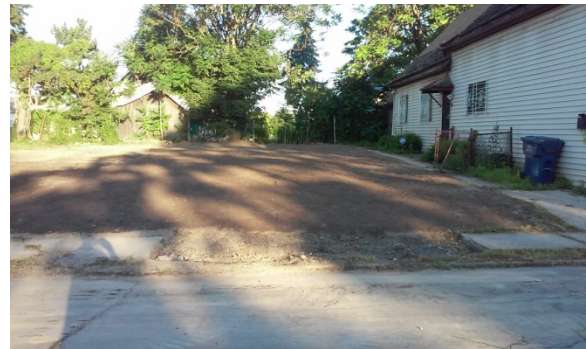
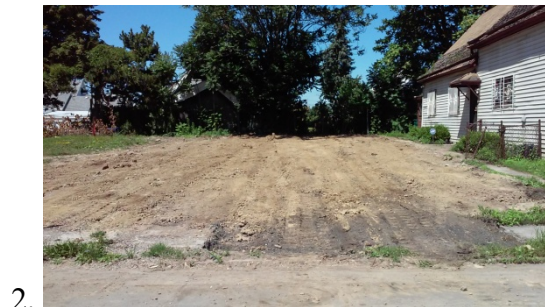
After:

SITE CONDITIONS:	Dry, sunny, hot
AMOUNT OF TOPSOIL USED ON SITE:	40 yards
HYDRO SEED/HAND SEED:	Hand seed
AMOUNT OF SEED USED ON SITE:	14 pounds
MACHINERY USED:	Skidsteer with scarifier and bucket, rakes, seed spreader, roller.
RUBBLE/DEBRIS, TYPE:	Rocks and roots.
RAINCHECK SIGN:	
PHOTOGRAPHS OF SITE:	Before (1, 2) and After, attached below.

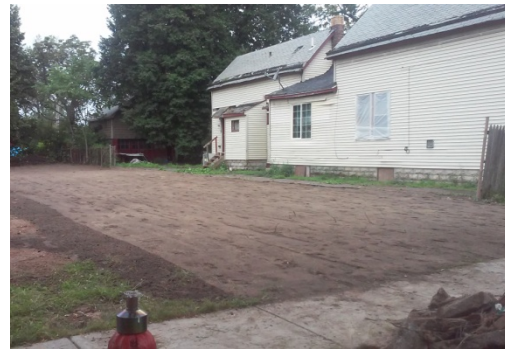
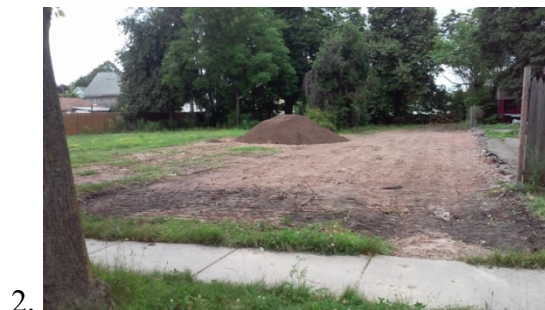
After:

SITE CONDITIONS:	Dry and cloudy
AMOUNT OF TOPSOIL USED ON SITE:	50 yards
HYDRO SEED/HAND SEED:	Hydro seed
AMOUNT OF SEED USED ON SITE:	21 pounds
MACHINERY USED:	Skidsteer with bucket and scarifier, rakes, seed spreader, roller.
RUBBLE/DEBRIS, TYPE:	Very large concrete slabs, large sticks
RAINCHECK SIGN:	
PHOTOGRAPHS OF SITE:	Before (1,2) and After, attached below.

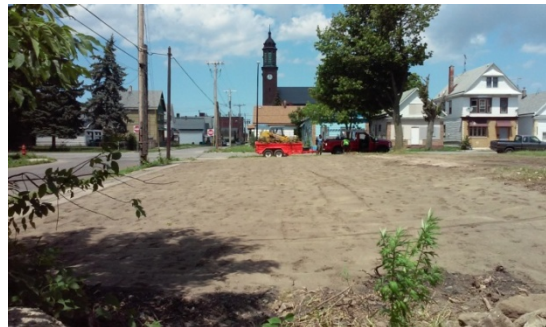
After:

SITE CONDITIONS:	Dry, very sloped site
AMOUNT OF TOPSOIL USED ON SITE:	50 yards
HYDRO SEED/HAND SEED:	Hand seed
AMOUNT OF SEED USED ON SITE:	15 pounds
MACHINERY USED:	Skidsteer with scarifier and bucket, rakes, seed spreader, roller.
RUBBLE/DEBRIS, TYPE:	Rocky in-fill
RAINCHECK SIGN:	
FURTHER NOTES:	Significant slope and low areas requiring additional soil.
PHOTOGRAPHS OF SITE:	Before (1,2) and After, attached below.

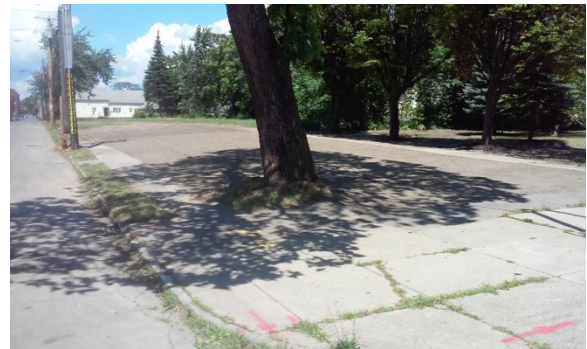
After:

SITE CONDITIONS:	Sunny, dry
AMOUNT OF TOPSOIL USED ON SITE:	40 yards
HYDRO SEED/HAND SEED:	Hand seed
AMOUNT OF SEED USED ON SITE:	11.5 pounds
MACHINERY USED:	Skidsteer with scarifier and bucket, rakes, seed spreader, roller.
RUBBLE/DEBRIS, TYPE:	In-fill rocky, large stones
RAINCHECK SIGN:	
PHOTOGRAPHS OF SITE:	Before (1, 2) and After, attached below.
